Moisture & Corrosion Performance of Cotton Duct Liner Materials in HVAC Ducts

In this issue, NAIMA reveals the results of moisture and corrosion tests conducted on cotton duct liner

Moisture and Corrosion Testing of Cotton Duct Liner Insulation

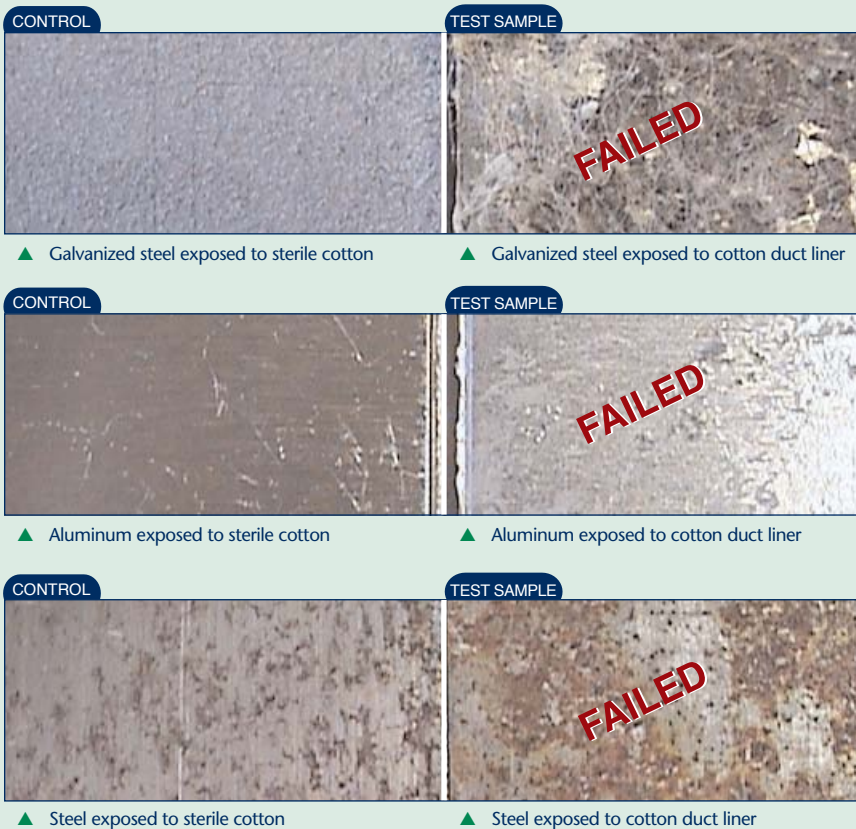
The photographs in Figure 1 show the difference between the corrosion caused by the cotton duct liner and the sterile cotton controls which were the results of the ASTM C 665 tests performed by the NAVLAP-certified lab. The cotton duct liner materials failed the ASTM test due to corrosion of the steel, aluminum and galvanized steel test coupons.

The ASTM C 665 corrosion criteria state that “the insulation shall show no corrosion greater than the comparative plates in contact with sterile cotton which has been tested in the same manner.” All of the metal coupons shown in Figure 1 below from the ASTM tests performed at a NAVLAP-certified lab had more corrosion than their comparative plate and therefore the product did not meet the requirements of ASTM C 665.

Figure 1: Difference Between Corrosion Caused by Cotton Duct Liner and Sterile Cotton Controls Based on ASTM C 665 Test

Specially cleaned plates of steel, galvanized steel, and aluminum were sandwiched between samples of the cotton duct liner material and placed in a chamber maintained at $95 \pm 3\%$ relative humidity and a temperature of $120 \pm 3^\circ\text{F}$. The steel samples were tested for 96 ± 2 hours while the aluminum and galvanized steel samples were tested for 720 ± 2 hours.

The test samples were then assessed by NAVLAP-certified labs against a set of comparative plates. The comparative plates consisted of identical metal test plates that were sandwiched between pieces of washed sterile cotton and exposed to the same temperature and humidity conditions for the same period of time.

NOTE: Copper was also tested, but showed no corrosion. Copper is rarely in contact with duct liner materials.

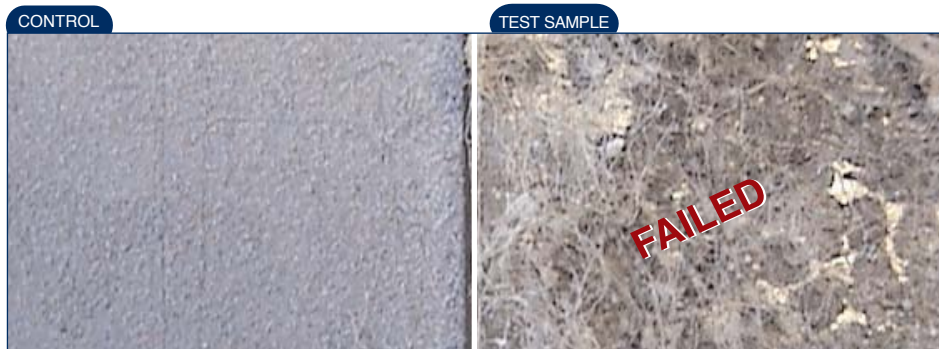
▲ Galvanized steel exposed to sterile cotton ▲ Galvanized steel exposed to cotton duct liner

Steel, galvanized steel and aluminum plates were sandwiched between samples of cotton duct liner material and placed in a chamber maintained at 95 ± 3% relative humidity and a temperature of 120 ± 3°F. Steel samples were tested for 96 ± 2 hours. Aluminum and galvanized steel samples were tested for 720 ± 2 hours.

When compared to control plates sandwiched between pieces of washed sterile cotton and exposed to the same temperature and humidity conditions for the same period of time, the cotton duct liner test samples showed more corrosion.

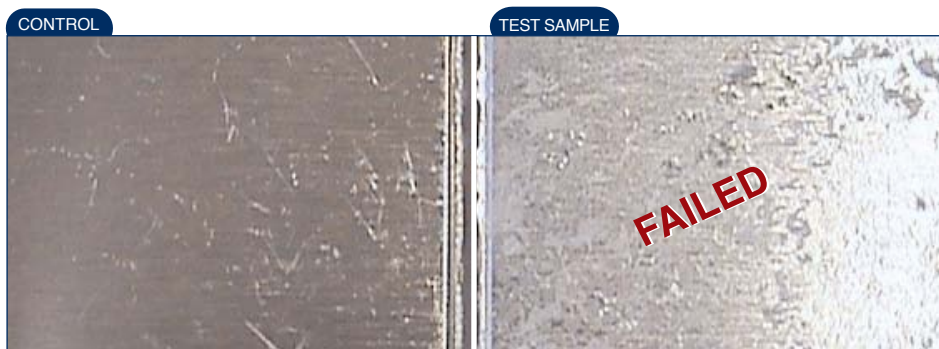
▲ Aluminum exposed to sterile cotton ▲ Aluminum exposed to cotton duct liner

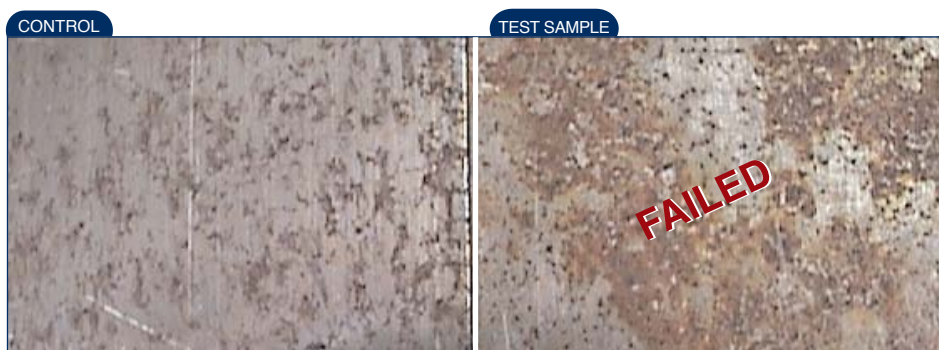
▲ Steel exposed to sterile cotton ▲ Steel exposed to cotton duct liner
